Visual Inspection and Hardness Test of Fatigue Damage in Shaft Latching of Slab Tong

Abstract. Visual inspection and hardness tests were conducted to investigate the fatigue failure of the shaft latching component on a slab tong used in a truck-mounted crane system. After nearly nine years of repetitive operation under dynamic loading, the shaft latching fractured during use. The fracture surface displayed typical signs of fatigue failure, such as smooth, shiny areas and semi-circular patterns, indicating progressive crack propagation over time. To complement the visual findings, a hardness test was performed using an Equotip 2 device. The purpose of this research is to know the type of damage that occurs in shaft latching. The result showed a surface hardness of 41 HRC, significantly below the recommended 60 HRC for components subjected to cyclic loads. Based on visual evidence and comparison with theoretical references, the failure was classified as unidirectional bending fatigue. The shaft material, AISI 4140 alloy steel, may have experienced decreased fatigue resistance due to insufficient hardness and prolonged exposure to cyclic stress. The fracture occurred at a high-stress

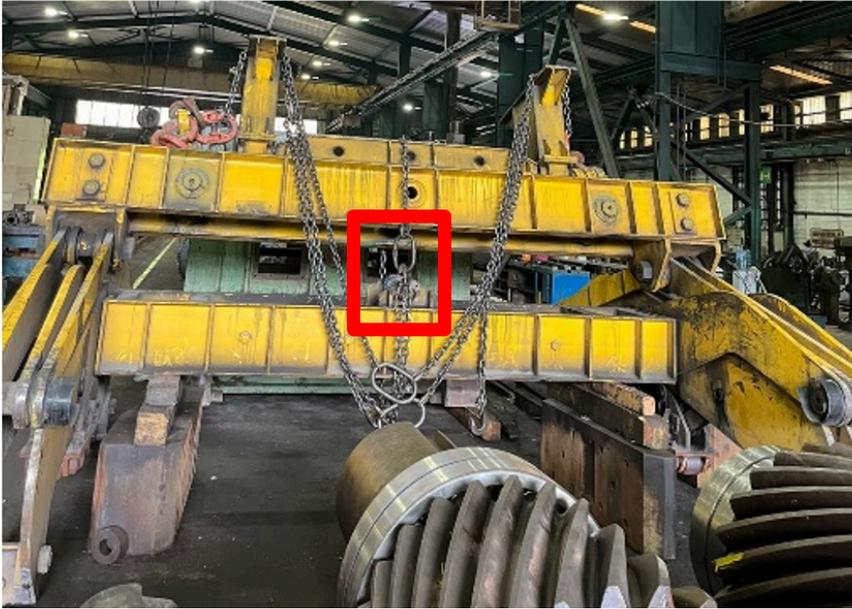
Fig. 1. Caption of the Figure 1. Below the figure.

The specimen used was a shaft latching located on a tong slab where it was damaged. The tong slab can be seen in Figure 1.

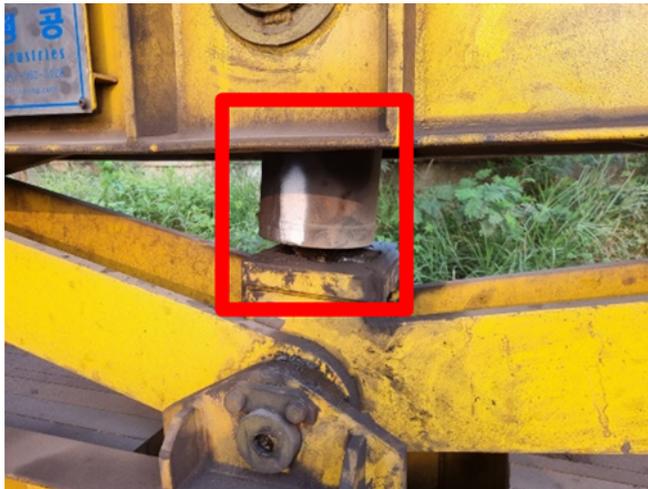
The position of the latching can be seen in the part marked in red. For more details, see Figure 2.

Fig 2. Location of Shaft Latching

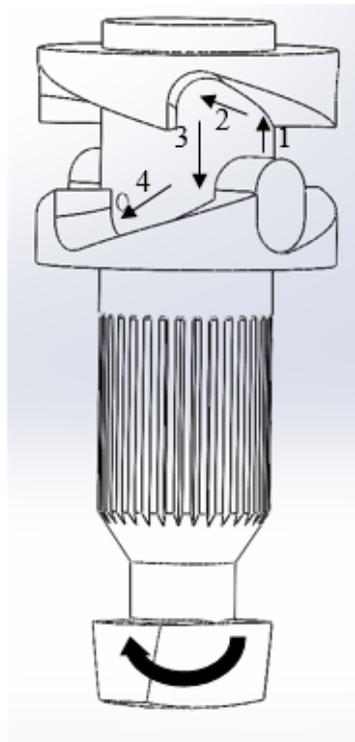
The Shaft Latching was damaged due to repeatedly holding the weight of the Slab Tong hand of 10.5 tons over a period of use for approximately 9 years. How the shaft latching itself works can be seen in the scheme in Figure 3. Where for the number and arrow number 1, the shaft latching will rise due to the pressure that occurs. Then, for the arrow and number 2, there is a movement process to the 45° point for the locking process. The third step is the process of lowering the shaft latching because the latching is lifted by the slab tong. Finally, the shaft latches in the 90° position to lock the slab tong arm and lift it.

Fig 3. Scheme of Shaft Latching's Works

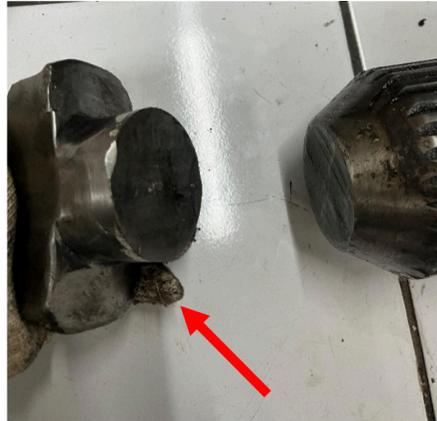
The fractured portion of this specimen will be removed and cleaned. This is done to ensure proper observation. The part used can be seen in Figure 4.

Fig 4. The part used as Specimen

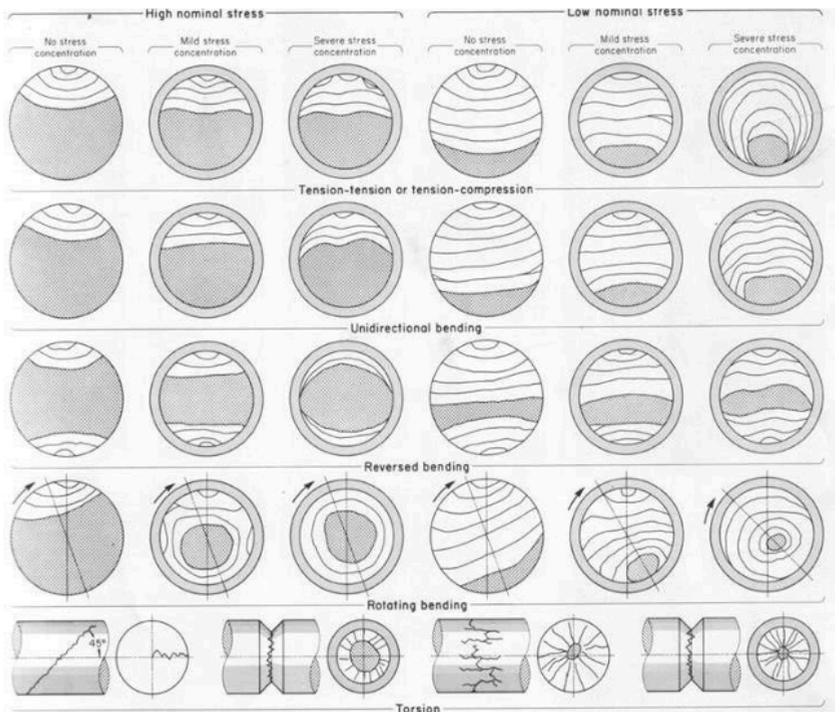
The damage that occurred is suspected to be fatigue failure. Fatigue failure type data was analyzed by comparing the damage images on the components and images sourced from books as a fatigue failure reference [8]. The types of fatigue can be seen in Figure 5.

Fig 5. The types of fatigue [8]

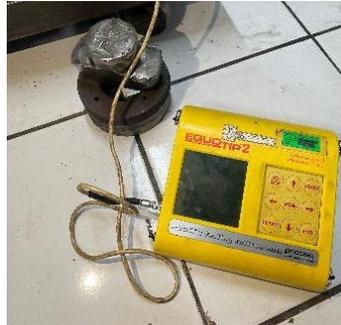
In order to support the visual inspection, a hardness inspection of the broken latching shaft was also carried out. This examination uses the Equotip O2 machine [9]. This tool uses

a dynamic loading method. The pen is loaded by rotating it. Then, adjust the hardness unit you want to achieve from the test on the monitor. After that, position the pen on the surface of the specimen to be tested. The test is carried out by pressing the tip of the pen, then the impact body of the spherical test tip and the permanent magnet in the pen will fall and bounce. The results will appear on the screen. The testing tool can be seen in Figure 6.

Fig 6. Hardness Testing Tool

Hardness testing was also performed on the fracture surface of the shaft latching. This examination used equotip 2 with a dynamic loading method. The test results showed a hardness of 41 HRC. This clearly does not comply with the requirement for a hardness of 60 HRC.

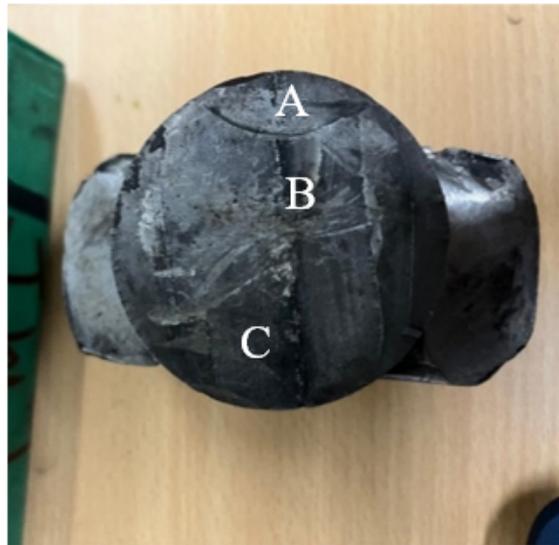
Once the broken part is cleaned, move on to the visual inspection process. The fracture site is then mapped. This mapping is divided based on the resulting fracture visualization. The mapping results can be seen in Figure 7.

Fig 7. The Mapping Results

The fracture of the shaft latching is shown by the red circle in Figure 7. The fatigue failure above is unidirectional bending, which is a material fatigue phenomenon that occurs due to loading in one direction. This term refers to the process where the material experiences repeated stress or strain gradually and eventually fails. The structural integrity of the material decreases over time due to the application of repeated loads, even though the load is below the material's tensile strength limit. More clearly, the damage can be seen in Figure 9.

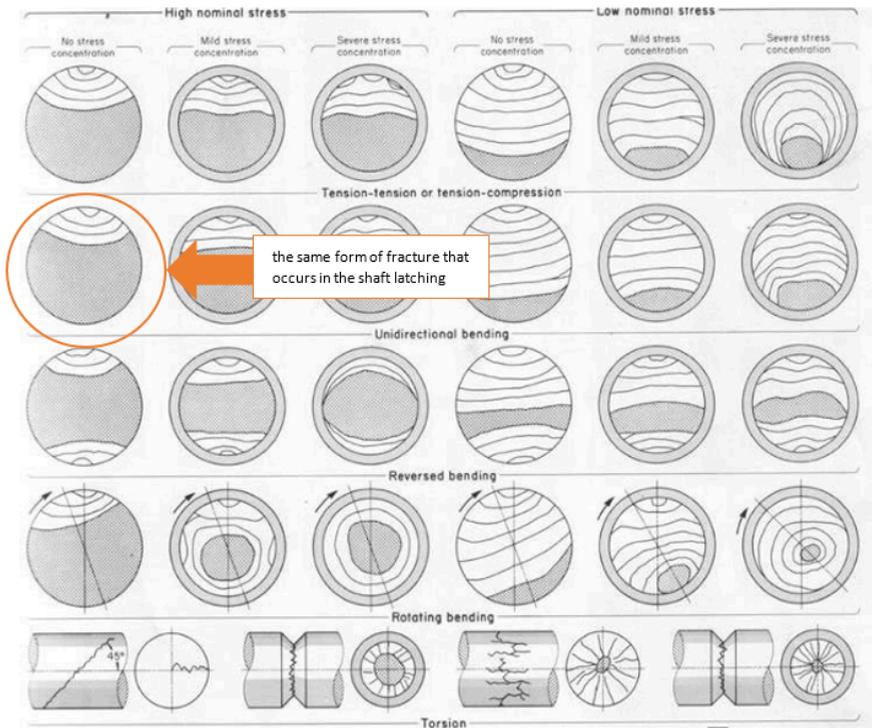
After mapping, the resulting fractures or damage clearly showed a typical fatigue pattern. Next, a comparison of the fracture shape was carried out with the literature reference. The fracture shape can be seen in Figure 8.

Fig 8. The Fracture Shape

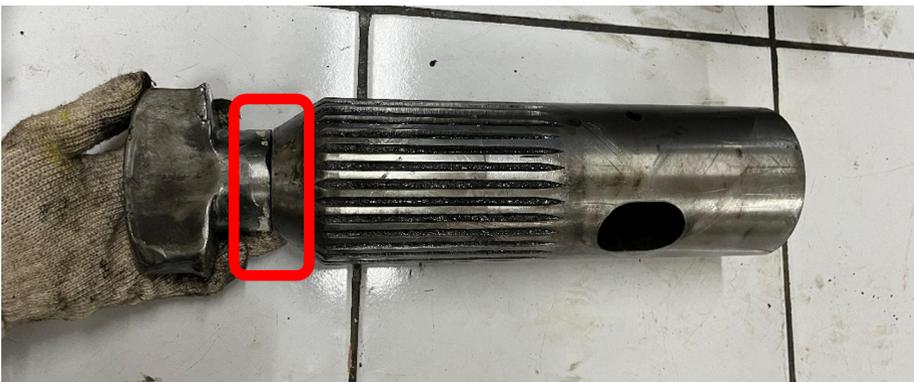
Fig 9. The Damage of Shaft Latching

The result of the visual inspection was the appearance of cracks and fractures in the center of the latching shaft. These fractures clearly show typical fatigue crack surfaces. The pattern is in the form of a semicircle that leads from one starting point of the microcrack

outwards. However, no traces of significant plastic deformation were found, indicating that the fracture occurred abruptly after the crack propagation phase.

For more detail, the surface of the crack looks relatively smooth and shiny. This is a strong indication that the damage occurred due to fatigue (material fatigue) and not just a momentary overload. Furthermore, no signs of damage caused by severe friction were found, suggesting the damage was not caused by a direct impact, but rather by the accumulation of cyclic stresses.

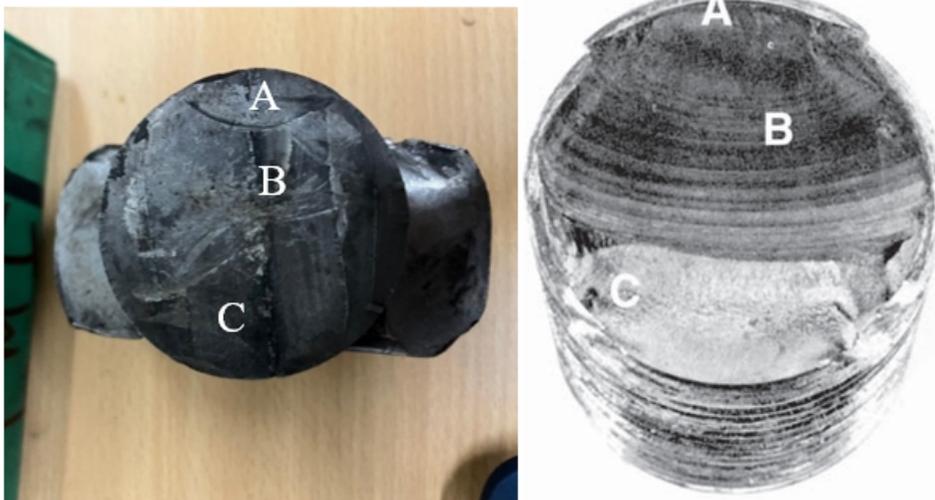
Based on previous observations, the main damage was a fracture in the shaft, which was indicated as damage due to unidirectional bending fatigue. This can be influenced by the service life of the shaft latching. The shaft latching operates in a mechanical system that moves up and down and rotates repeatedly every time the slab tong is used to lift the steel slab. The load that must be supported by the slab tong is around 10.5 tons. Furthermore, this slab latching has been used for 9 years at a high working frequency. During time, the shaft latching has experienced cyclic or repetitive loads that ultimately cause stress accumulation at critical points. This repetitive stress is the main cause of the appearance of cracks in the material, which continue to spread until they cause complete fracture, even though there is no direct excessive load.

The fracture occurred in the area of the shaft experiencing the highest stress, which is the bending area due to the load from the locking and unlocking mechanism of the slab tong. The result of the fatigue is unidirectional bending. This is a material fatigue phenomenon that occurs due to loading in one direction. Where the material experiences a gradual, repeated process of pressure or strain and eventually fails. The structural integrity of the material decreases over time due to the application of repeated loads, even if the loads are below the tensile strength limit of the material. This can be seen in Figure 10.

Fig 10. The Undirectional Bending Fatigue's
